Manhole Inspection Summary

Manhole # S27M__030MH

Insp Date: **5/2/08 11:12 AM**

Location Address: **1142 Washington BD (behind)**

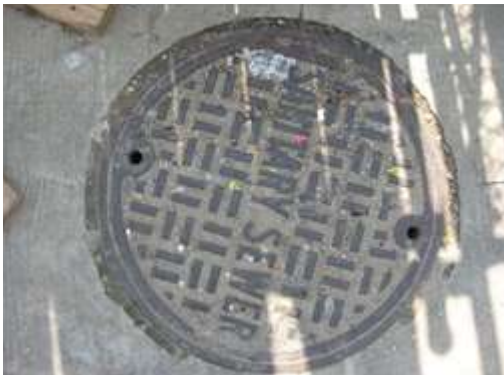
Cover View

Condition: **Sound**

Cover Material: **Cast Iron**

Properties: ☐ Bolted ☒ Vented ☐ Water Tight ☐ Water Tight Insert

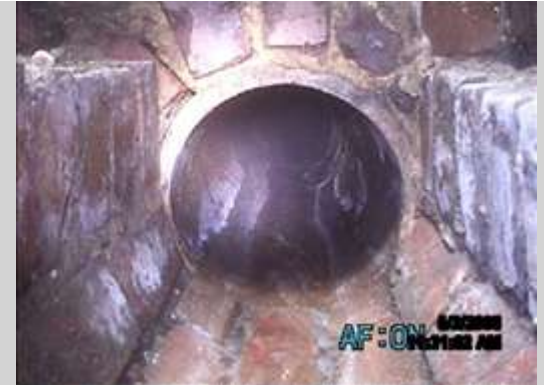
12 O'Clock Outflow

8 in. Circular Gravity Sewer
Pipe Out @ 12 O'Clock

Pipe Height: **8.4** (in.) Rod and Bar (Angled)
Pipe Material: **Clay** ☐ Pipe Lined
Invert Depth: **6.41** (ft.) Flow Characteristics: **Slow**
Deposits: ☒ None ☐ Mud ☐ Sludge ☐ Debris ☐ Grease
Silt Depth: **0** (in.) Deposits Extent:
Infiltration: **None** Pipe Seal Cond: **Sound**

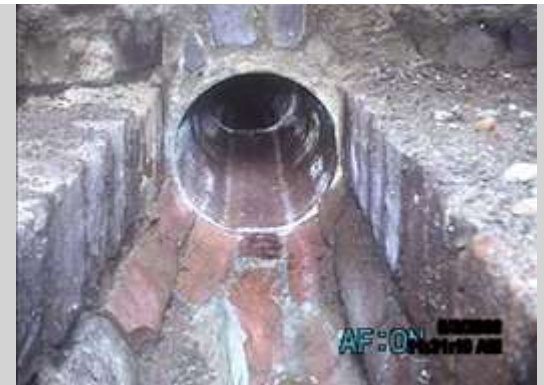
6 O'Clock Inflow

8 in. Circular Gravity Sewer
Pipe In @ 6 O'Clock

Pipe Height: **8.4** (in.) Rod and Bar (Angled)
Pipe Material: **Clay** ☐ Pipe Lined
Invert Depth: **6.22** (ft.) Flow Characteristics: **Slow**
Deposits: ☒ None ☐ Mud ☐ Sludge ☐ Debris ☐ Grease
Silt Depth: **0** (in.) Deposits Extent:
Infiltration: **None** Pipe Seal Cond: **Sound**
